**Re: Minor Industrial, SIC 4952, NPDES Compliance Evaluation Inspection, Paa-Ko Wastewater Treatment Plant, NM0030724, December 17, 2015**

### NPDES Compliance Inspection Report

**Compliance Evaluation Inspection  
Paa-Ko Communities Sewer Association  
NPDES Permit No. NM0030724**

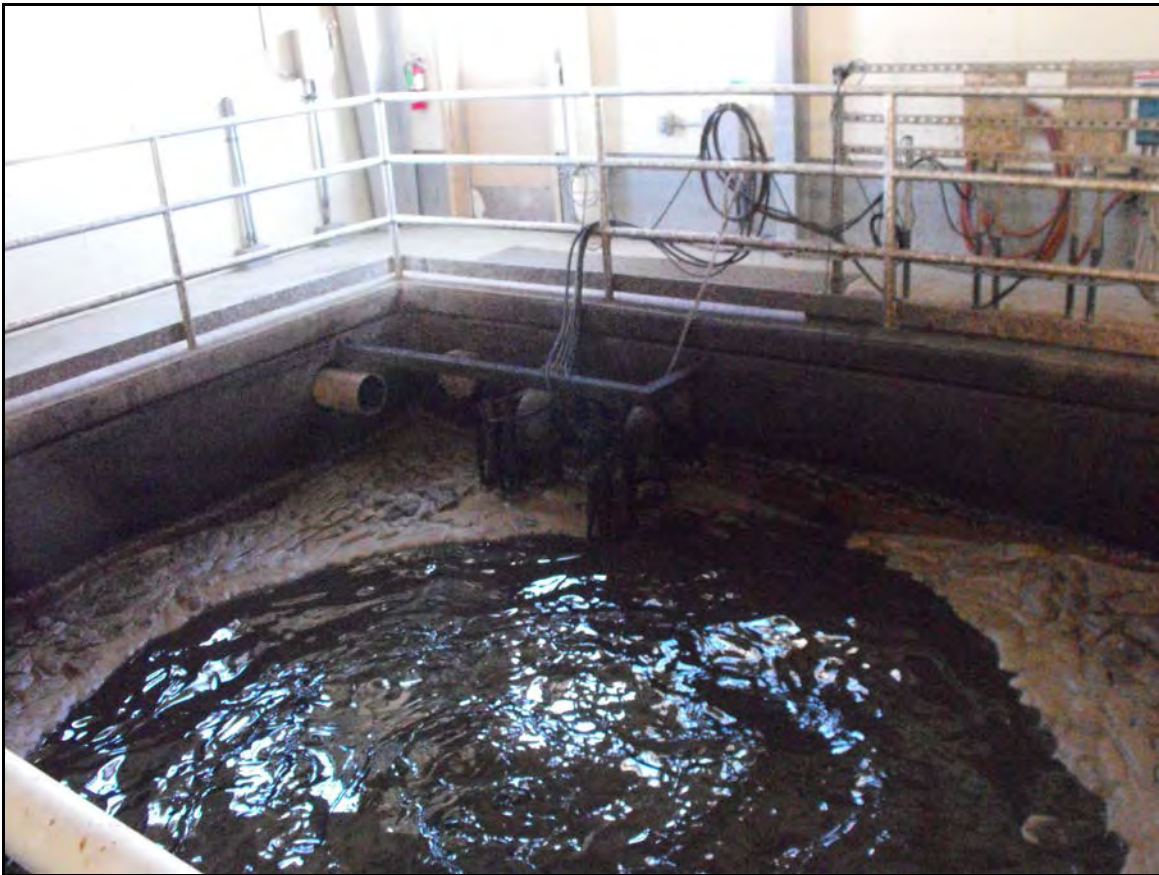
Photo # 1

Photographer: Daniel Valenta	Date: December 17, 2015	Time: 1147 hours
City/County: Sandia Park / Bernalillo County		
Location: Paa-Ko Wastewater Treatment Plant		
Subject: Anoxic basin where denitrification takes place.

This facility was previously a subsurface flow constructed wetland with infiltration beds. It was retrofitted with a membrane bioreactor (MBR) microfiltration system and became functional in December 2007. The collection system drains the residential septic systems. After final grit removal and filter at the WWTP the influent then flows into an anoxic basin where denitrification takes place (see photo 1). From the anoxic basin, influent then enters a MBR microfiltration basin. Through the use of a permeate pump, a vacuum is applied to a header connected to the membranes. The vacuum draws the treated water through the hollow fiber ultrafiltration membranes (see photo 2). Permeate is then directed to UV disinfection (see photo 3).

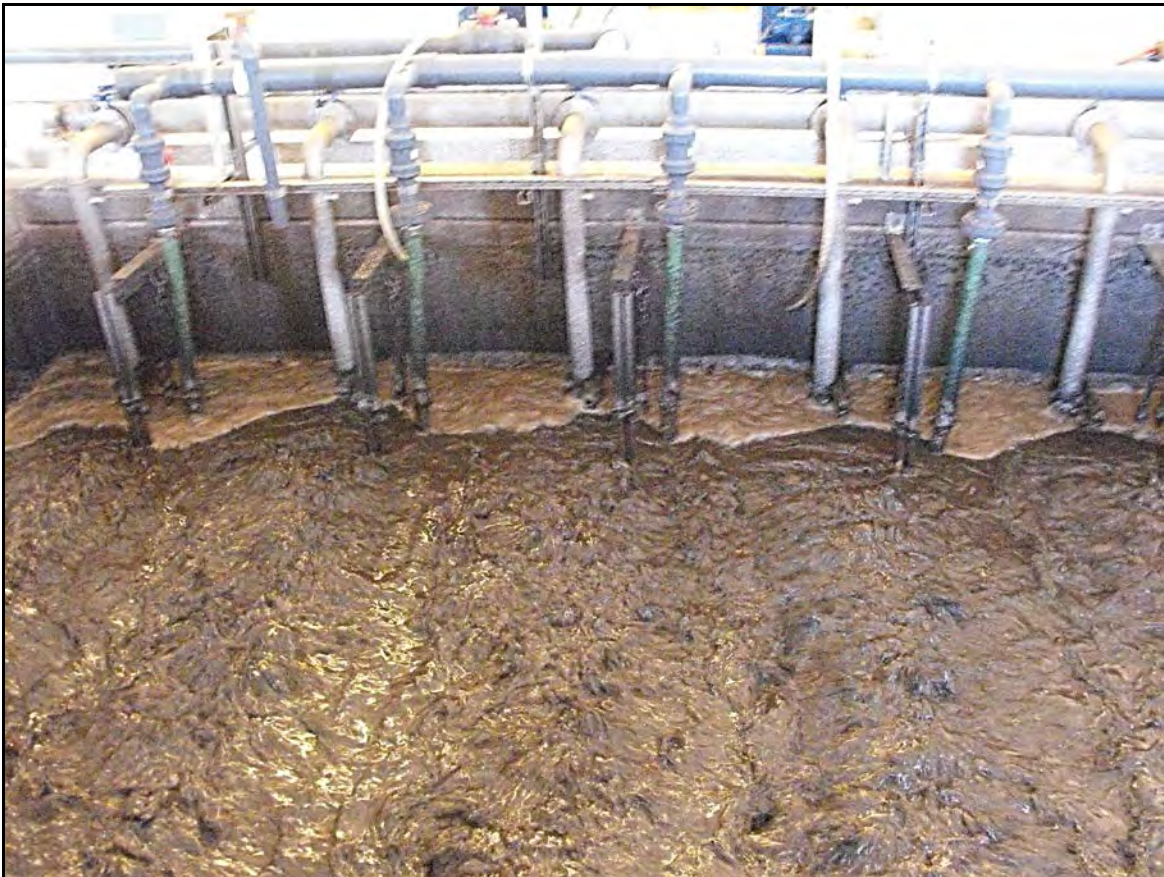
Photo # 2

Photographer: Daniel Valenta	Date: December 17, 2015	Time: 1148 hours
City/County: Sandia Park / Bernalillo County		
Location: Paa-Ko Wastewater Treatment Plant		
Subject: MBR microfiltration basin.

Intermittent airflow is introduced to the bottom of the membrane module, producing turbulence that scours the external surface of the hollow fibers. This scouring action transfers rejected solids away from the membrane surface. The system is controlled by a programmable logic controller, which if necessary, can be manually operated. If a system malfunction or power outage problem occurs the system will call the operators. There is a back up call system in place if the primary system fails. The outside UV disinfection system is not connected to the programmable logic controller system and no emergency call out system is presently in place. Effluent flows to a lined pond for storage or pumped directly to the Paa-Ko Ridge golf course pond.

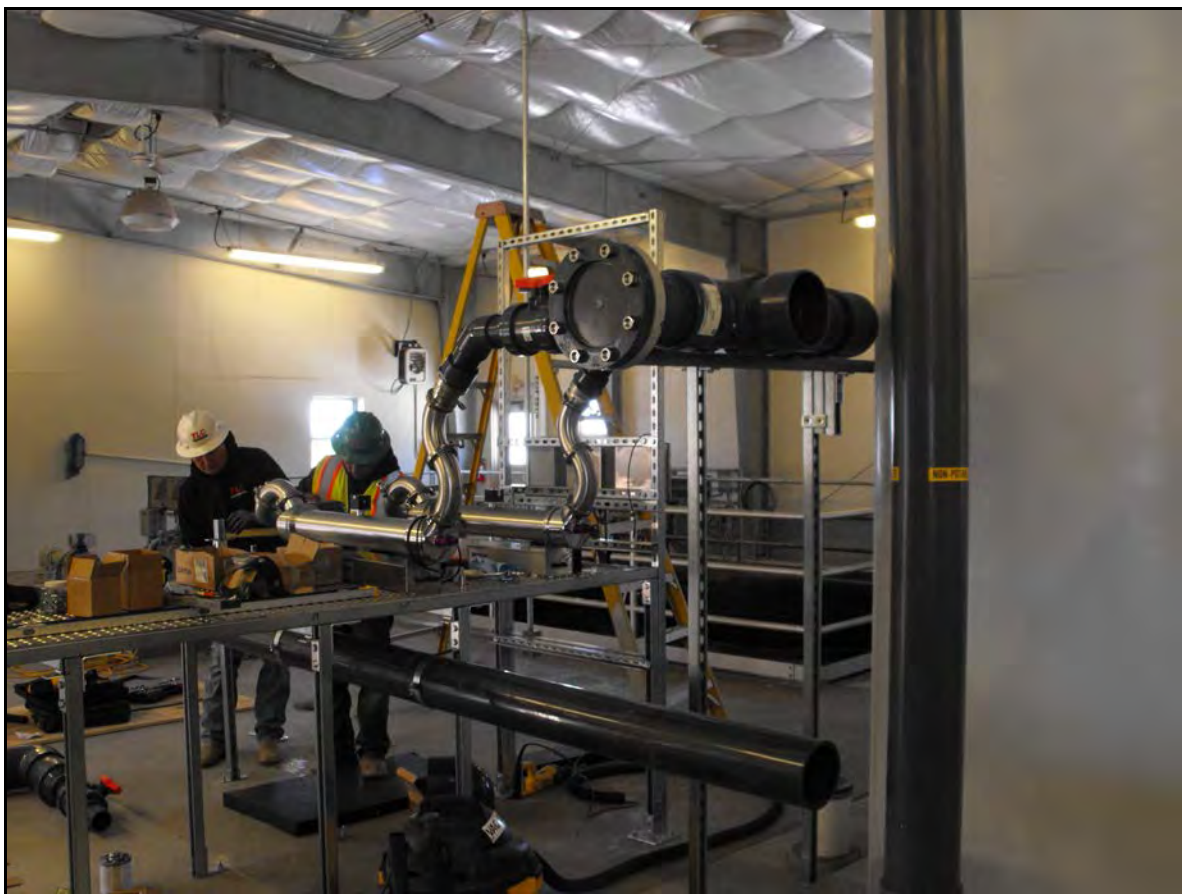
Photo # 3

Photographer: Daniel Valenta	Date: December 17, 2015	Time: 1151 hours
City/County: Sandia Park / Bernalillo County		
Location: Paa-Ko Wastewater Treatment Plant		
Subject: A new UV treatment system is being constructed. This moves the UV treatment system from outside the building to under cover from the elements.

Changes have been made to the facilities final treatment process, the UV disinfection Unit. The treatment unit in the past was outdoors exposed to rain, heat, and cold. Moving the unit indoors in a controlled environment will increase the efficiency and lifespan of a new unit. This change may trigger the above requirement.

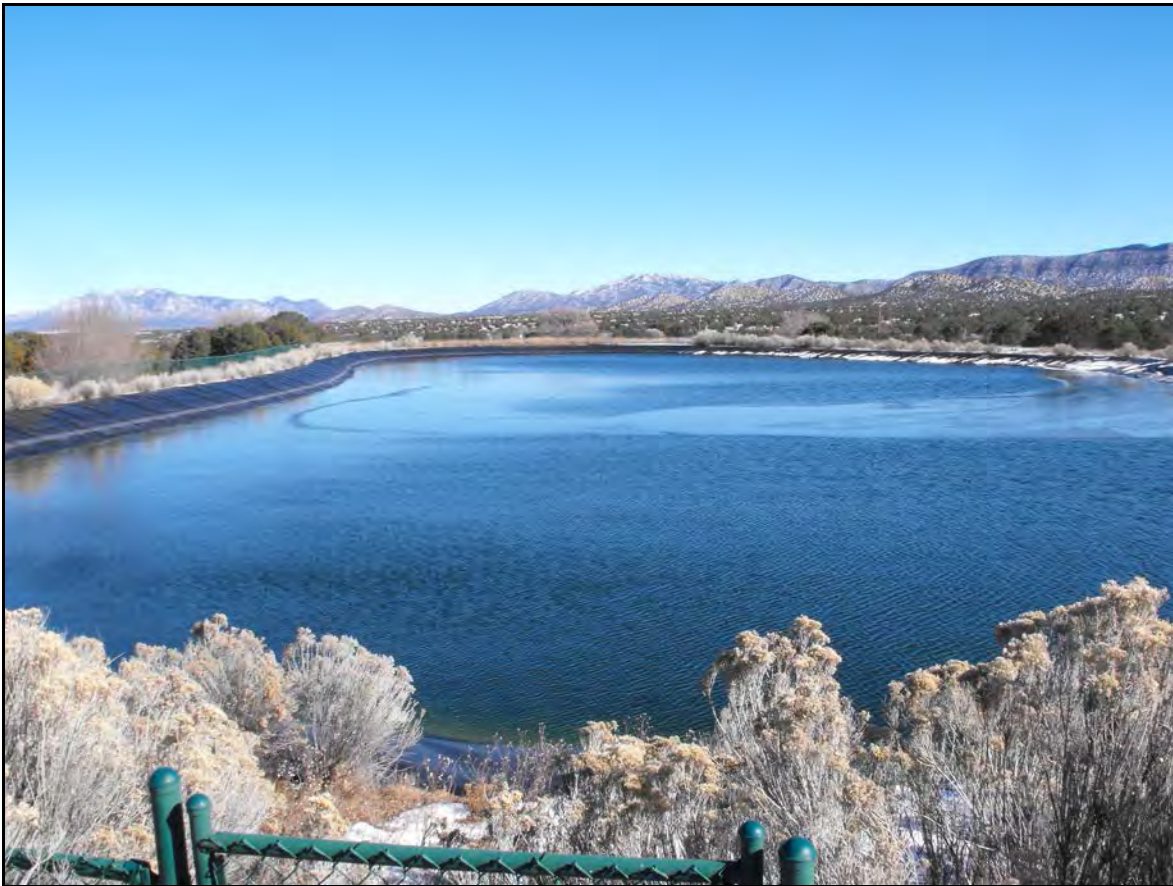
Photo # 4

Photographer: Daniel Valenta	Date: December 17, 2015	Time: 1211 hours
City/County: Sandia Park / Bernalillo County		
Location: Paa-Ko Wastewater Treatment Plant		
Subject: 6 million gallon lined retention pond.

Water from the 6 million gallon lined retention pond is pumped up to Paa-Ko golf course pond (see photo 4). A spill occurs when the golf course pond overflows. This may occur if the pumps are left on too long (see photo 5). Any discharge from the golf course pond would not accurately reflect the discharge from the wastewater treatment plant as it is greatly diluted with groundwater that the pond is supplemented with or any chemicals that may be introduced to the water from the pond itself (i.e. pesticides, herbicides, etc.).

At the WWTP, treated effluent travels through the UV system, the final treatment, and is discharged to a 6 million gallon lined retention pond. There is no overflow or outfall built into the retention pond. Where would a discharge occur at the retention pond if water is not removed? Should this be the true discharge location, Outfall 001?

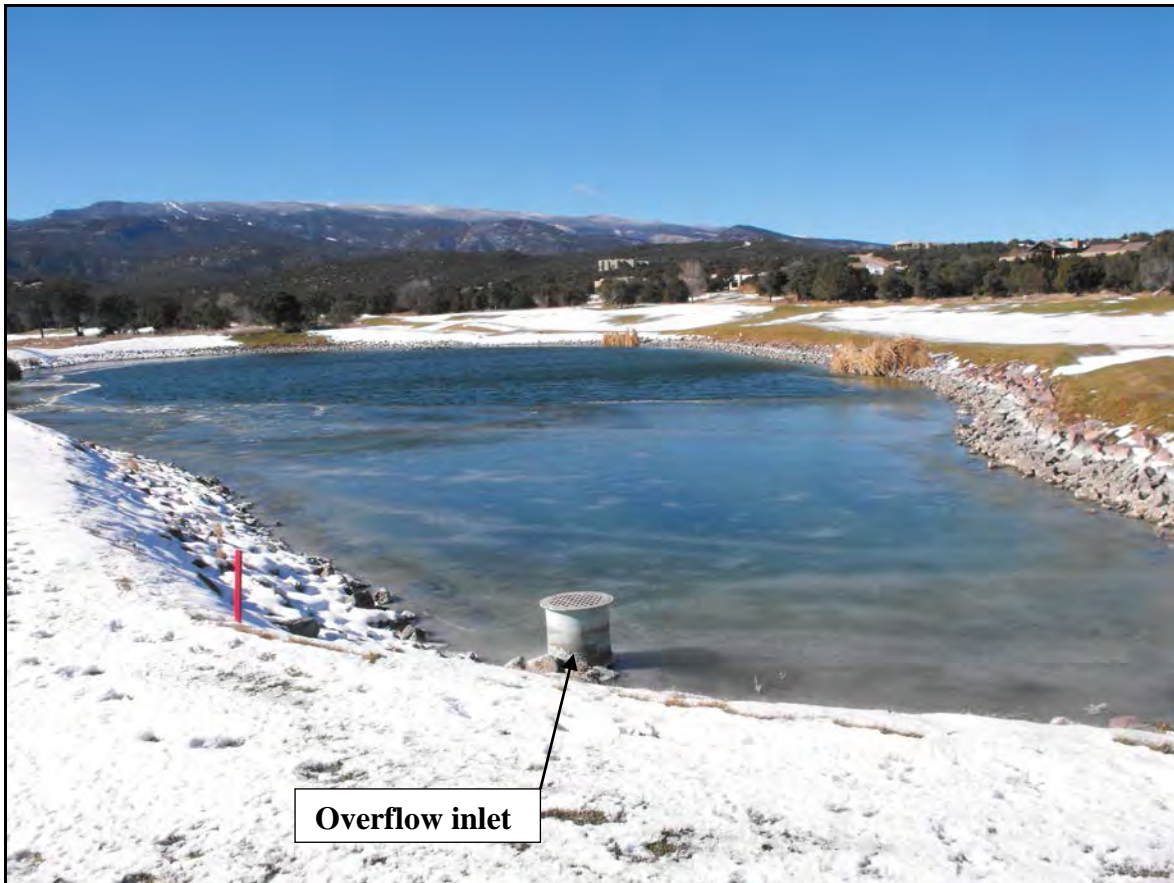
Photo # 5

Photographer: Daniel Valenta	Date: December 17, 2015	Time: 1222 hours
City/County: Sandia Park / Bernalillo County		
Location: Paa-Ko Wastewater Treatment Plant		
Subject: Paa-Ko golf course irrigation pond.

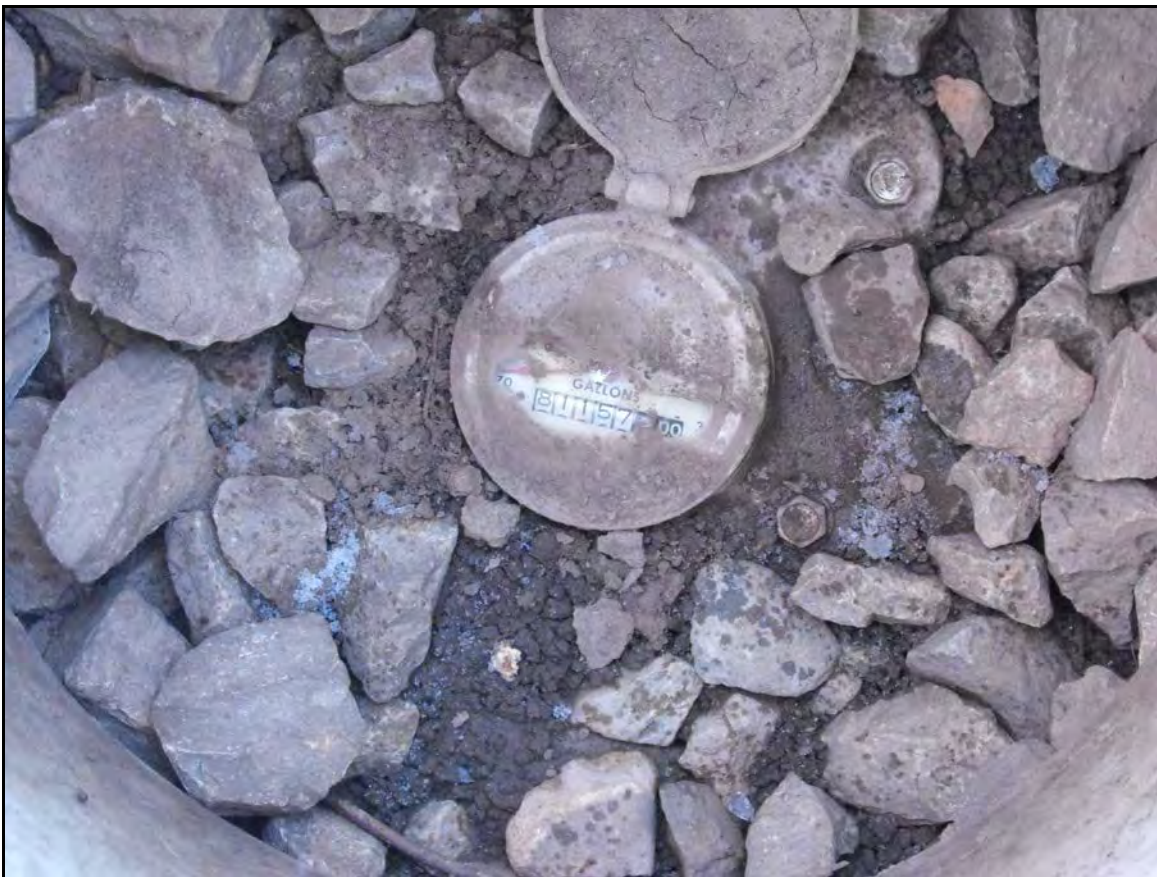
Photo # 6

Photographer: Daniel Valenta	Date: December 17, 2015	Time: 1222 hours
City/County: Sandia Park / Bernalillo County		
Location: Paa-Ko Wastewater Treatment Plant		
Subject: Flow meter to record event if the golf course pond were overfilled and a spill occur.

The facility was inspected before on January 10, 2013. At that time the meter on the golf course overflow pipe was recorded at (81157.200). This meter was checked again during this inspection. The meter read (81157.200) no change had occurred, (see photo 6). There was no visible indication in the sediment at the overflow pipe that a spill had occurred.
